# Manhole Inspection Summary

Manhole # S43C2\_030MH

Insp Date: **12/11/07 9:50 AM**

**Location** Address: **3835 Saint Margaret St**

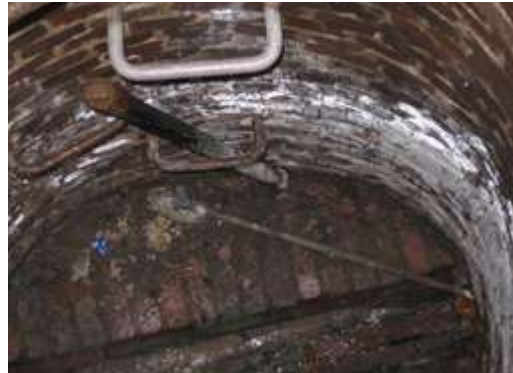
Defect 3

Poles

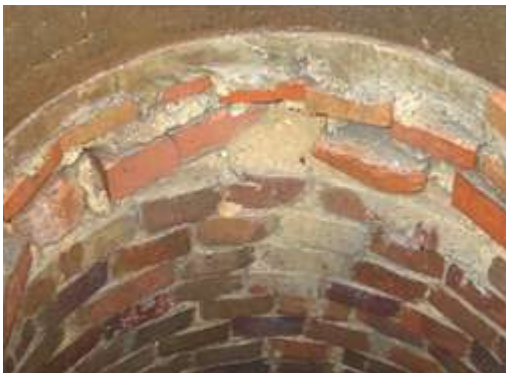
Defect 1

Condition: ☐ Sound ☐ Cracked ☐ Root Intrusion ☒ **Loose Brick** ☐ Deteriorated

Infiltration: ☐ None ☐ Joint ☐ Cracks ☒ **Mortar** ☐ Roots ☒ **Wall**

Infiltration: ☐ None ☐ Joint ☐ Cracks ☒ **Mortar** ☐ Roots ☐ Wall

Loose bricks/mortar

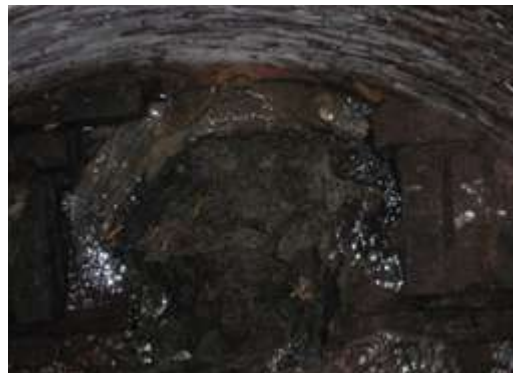
Defect 2

Condition: ☐ Sound ☒ **Cracked** ☐ Root Intrusion ☒ **Deteriorated** ☐ Leaks ☐ Debris

Condition: ☐ Sound ☒ **Cracked** ☐ Root Intrusion ☐ Deteriorated ☐ Leaks ☐ Debris

Bench broken/pipe covered

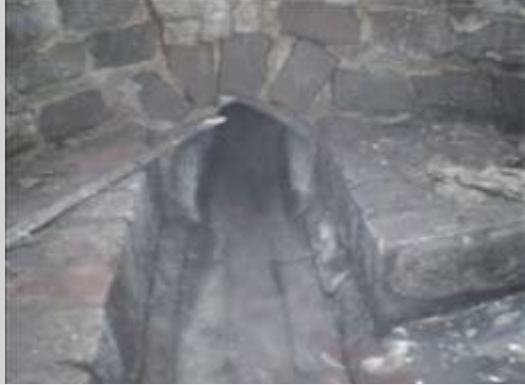
12 O'Clock Outflow

Pipe Height: **9.6** (in.) Rod and Bar (Angled)  
Pipe Material: **Clay** ☐ Pipe Lined  
Invert Depth: **10.39** (ft.) Flow Characteristics: **Fast**  
Deposits: ☒ None ☐ Mud ☐ Sludge ☐ Debris ☐ Grease  
Silt Depth: (in.) Deposits Extent:  
Infiltration: **None** Pipe Seal Cond: **Sound**

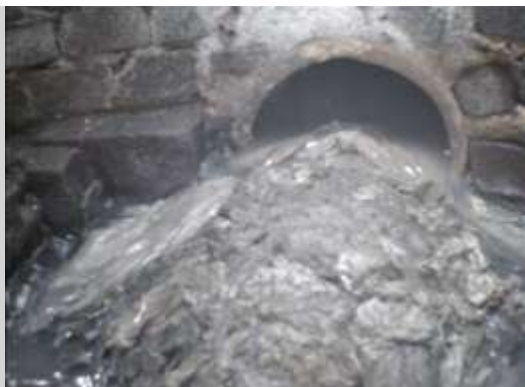
3 O'Clock Inflow

Pipe Height: **10.8** (in.) Rod and Bar (Angled)  
Pipe Material: **Clay** ☐ Pipe Lined  
Invert Depth: **9.97** (ft.) Flow Characteristics: **Fast**  
Deposits: ☒ None ☐ Mud ☐ Sludge ☐ Debris ☐ Grease  
Silt Depth: (in.) Deposits Extent:  
Infiltration: **None** Pipe Seal Cond: **Sound**

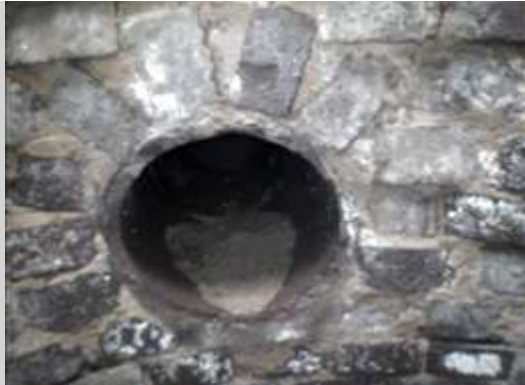
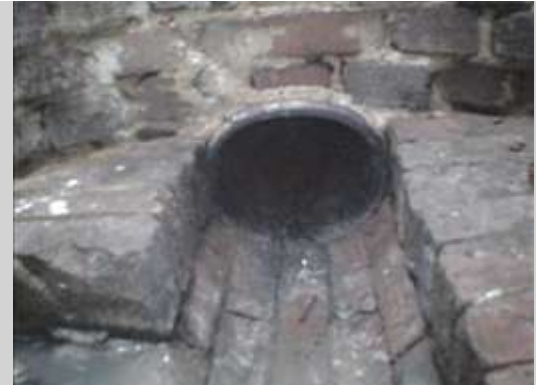
6 O'Clock Inflow

Pipe Height: **9.6** (in.) Rod and Bar (Angled)

Drop: **Outside** Rod and Bar

Drop Condition: **Open**
